**SPCC Inspection Photograph Log**

**Little Goose Lock and Dam**

**Inspection and Photograph Date: November 30, 2022**

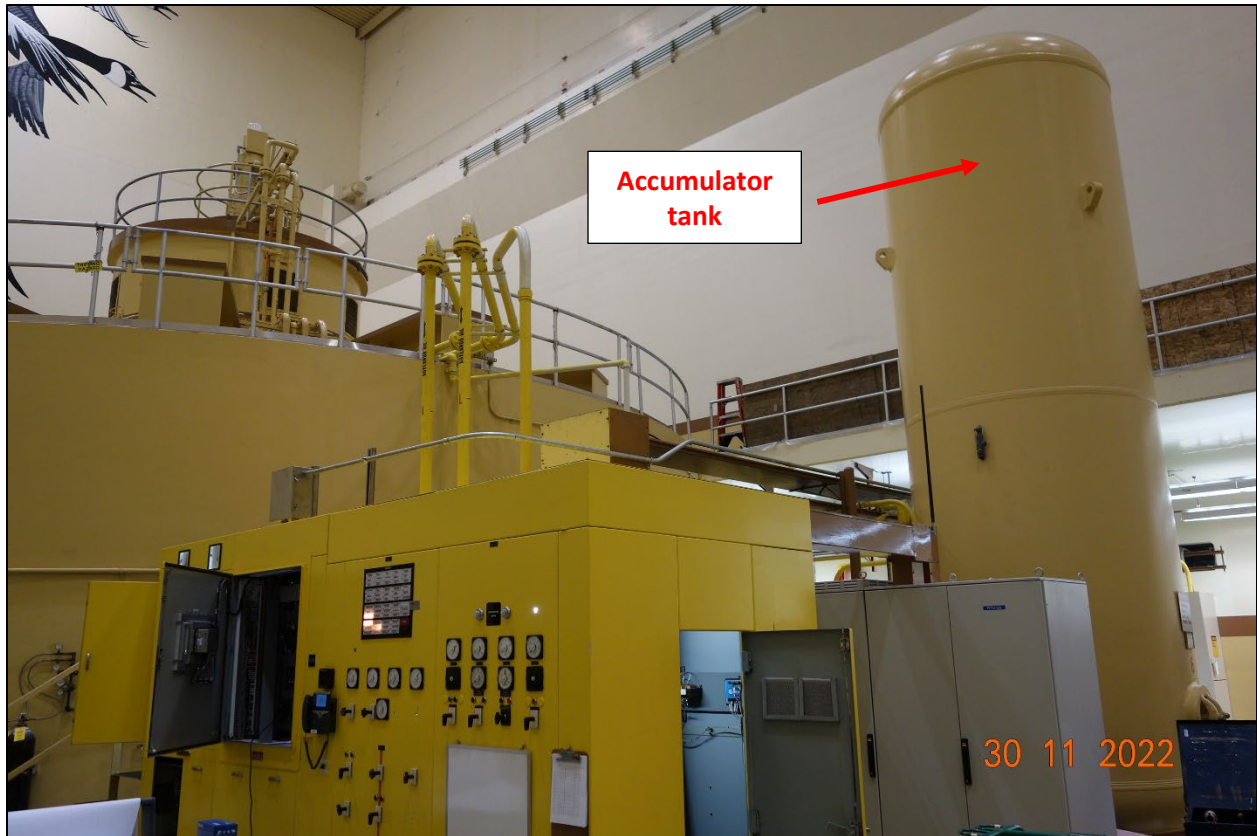
**Photograph 22.** View the accumulator tank for turbine 6.

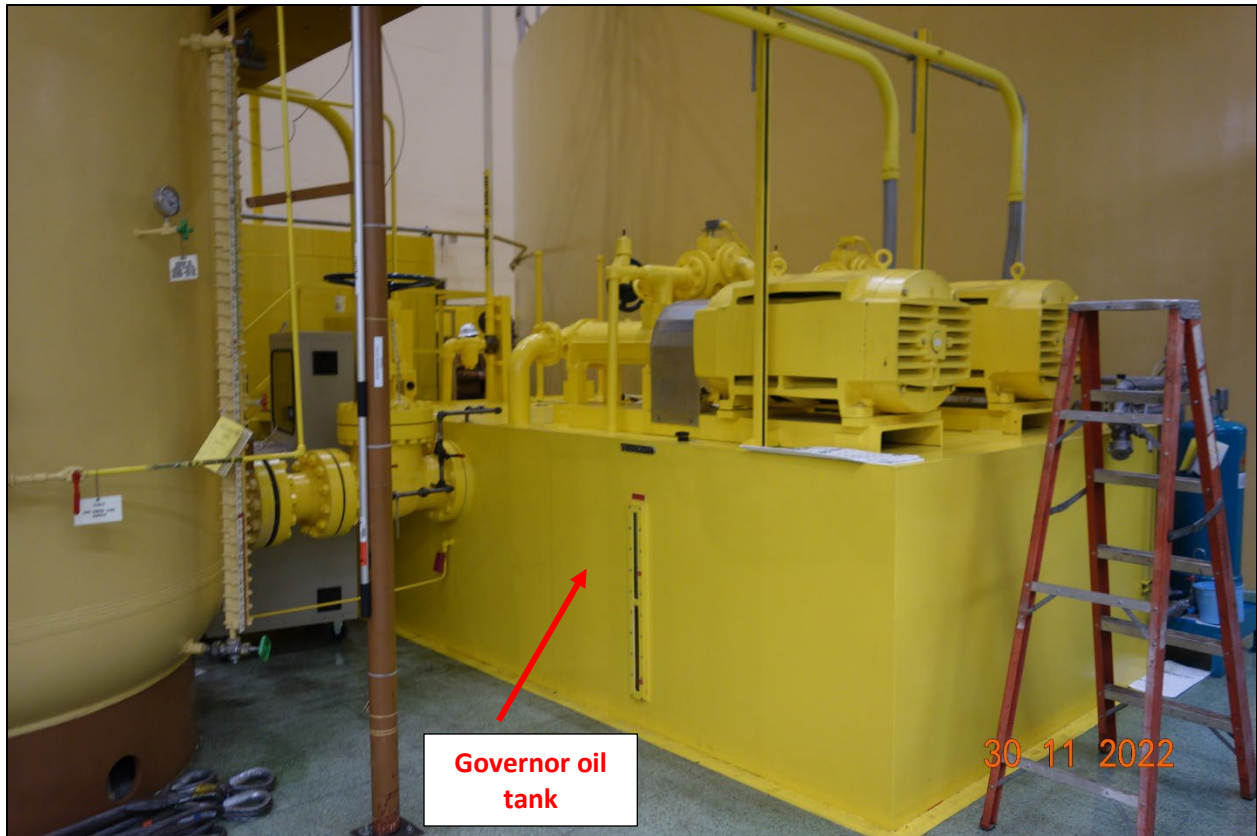
**Photograph 23.** View of the governor oil tank for turbine 6.

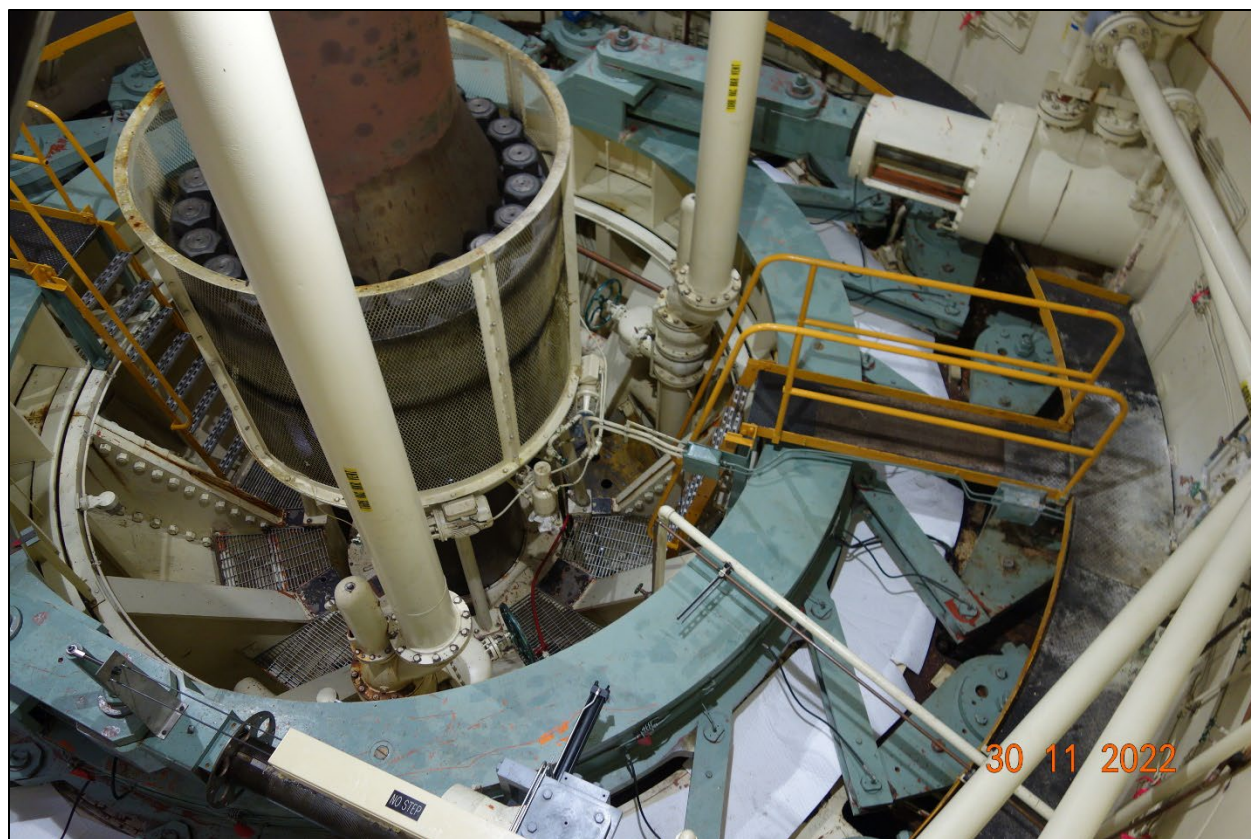
**Photograph 24.** View inside the turbine pit for turbine 6.
